# Manhole Inspection Summary

Manhole # S57E\_\_001MH

Insp Date: **7/29/08 9:30 AM**

**Location** Address: **26 s kresson st**

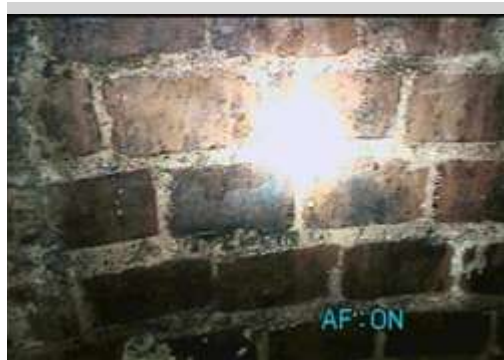
Defect 2

bench debris

infiltration in barrell

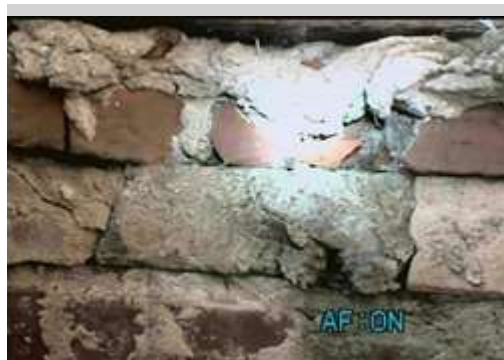
Defect 1

corroded steps

chimney loose bricks, cracked, frame adj

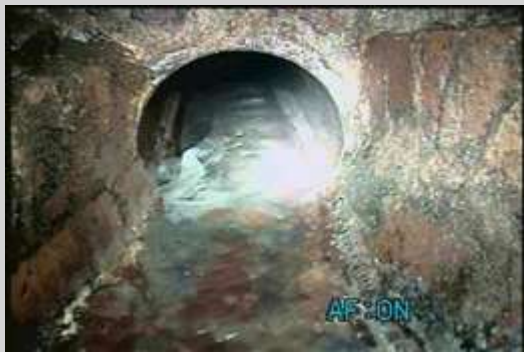
12 O'Clock Outflow

8 in. Circular Gravity Sewer  
Pipe Out @ 12 O'Clock

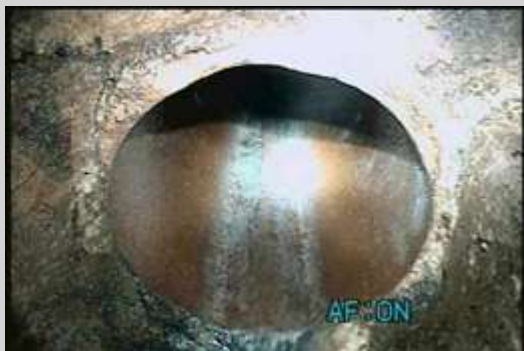
3 O'Clock Inflow

8 in. Circular Gravity Sewer  
Pipe In @ 3 O'Clock

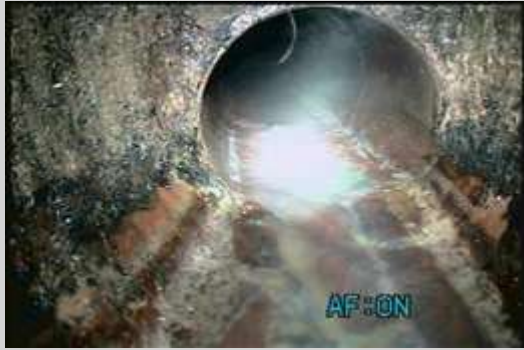
7 O'Clock Inflow

8 in. Circular Gravity Sewer

Pipe In @ 7 O'Clock
